# Manhole Inspection Summary

Manhole # S21W\_\_028MH

Insp Date: **11/11/08 10:01 AM**

**Location** Address: **2203 W. HAMBURG ST**

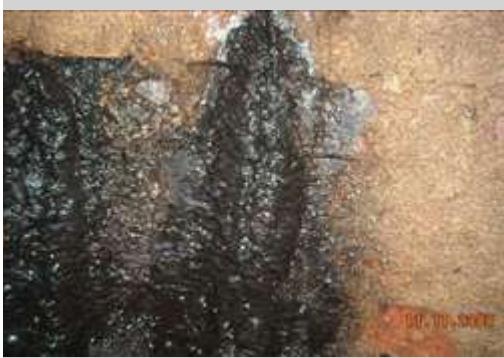
Defect 3

Infiltration: ☐ None ☐ Joint ☐ Cracks ☐ Mortar ☐ Roots ☒ **Wall**

INFILTRATION @ BARREL WALL

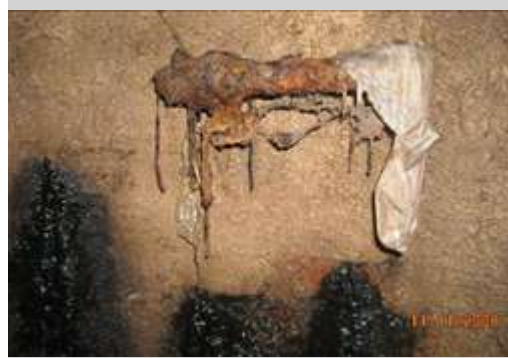
Defect 2

☒ **Evidence Of Surcharge**

Depth: **5** (ft.) ☐ Active Surcharge Present

EVIDENCE OF SURCHARGE

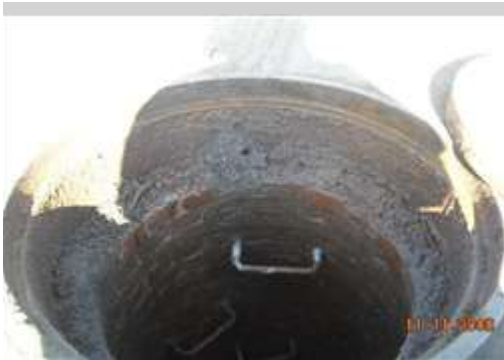
Defect

Subject To Ponding: **Sheeting**

☒ **Leaks**

FRAME LEAKS\_INFLOW EVIDENCE  
FROM SHEETING

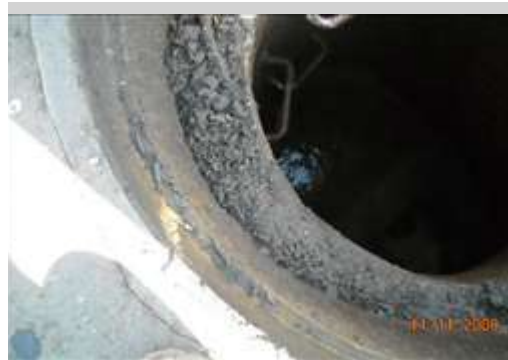
Defect 1

Offset: **3** (in.)

FRAME OFFSET

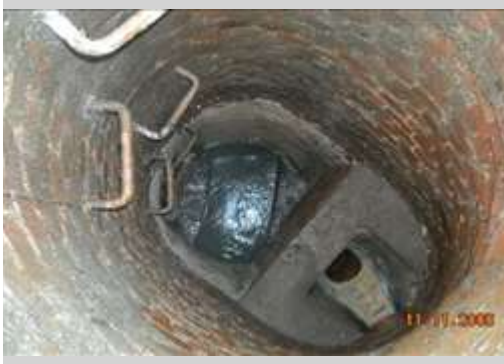
### Defect

Count: **9** Missing: **0** ☒ **Corroded**

corroded steps

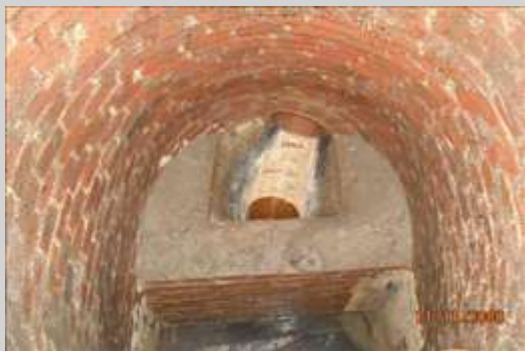
5 O'Clock Inflow

8 in. Circular Gravity Sewer  
Pipe In @ 5 O'Clock

Pipe Height: **8.4** (in.) Rod and Bar (Angled)  
Pipe Material: **Clay** ☐ Pipe Lined  
Invert Depth: **8.20** (ft.) Flow Characteristics: **Slow**  
Deposits: ☒ None ☐ Mud ☐ Sludge ☐ Debris ☐ Grease  
Silt Depth: **0** (in.) Deposits Extent:  
Infiltration: **None** Pipe Seal Cond: **Sound**

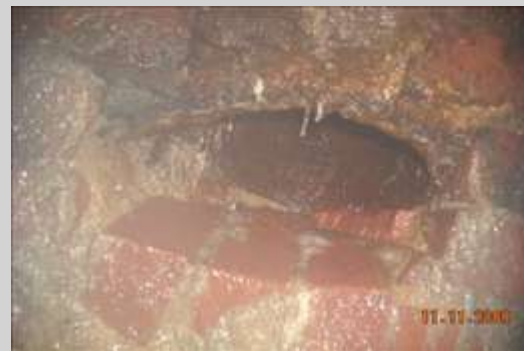
Drop In @ 5 O'Clock

Drop: **Inside** Rod and Bar  
Angled: **Yes** Reading: **14.24** (ft.)  
Inv Depth: **15.24** (ft.)  
Drop Condition: **Open**

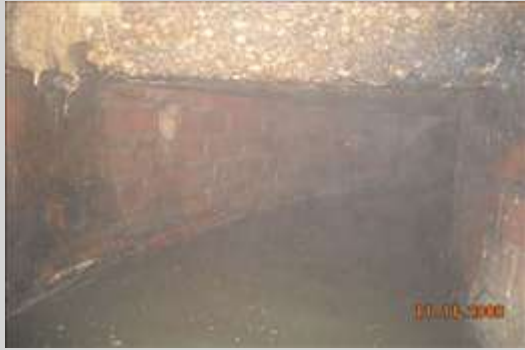
7 O'Clock Inflow

24 in. Circular Gravity Sewer

Pipe In @ 7 O'Clock

Pipe Height: **24** (in.) Rod and Bar (Angled)

Pipe Material: **Unknown** ☐ Pipe Lined

Invert Depth: **16.38** (ft.) Flow Characteristics: **Fast**

Infiltration: **None** Pipe Seal Cond: **Sound**
